MAIN ELEMENTS SURVEY
OF

1 ACACIA AVENUE
BRISTOL

FOR AND ON BEHALF OF
MR & MRS SMITH

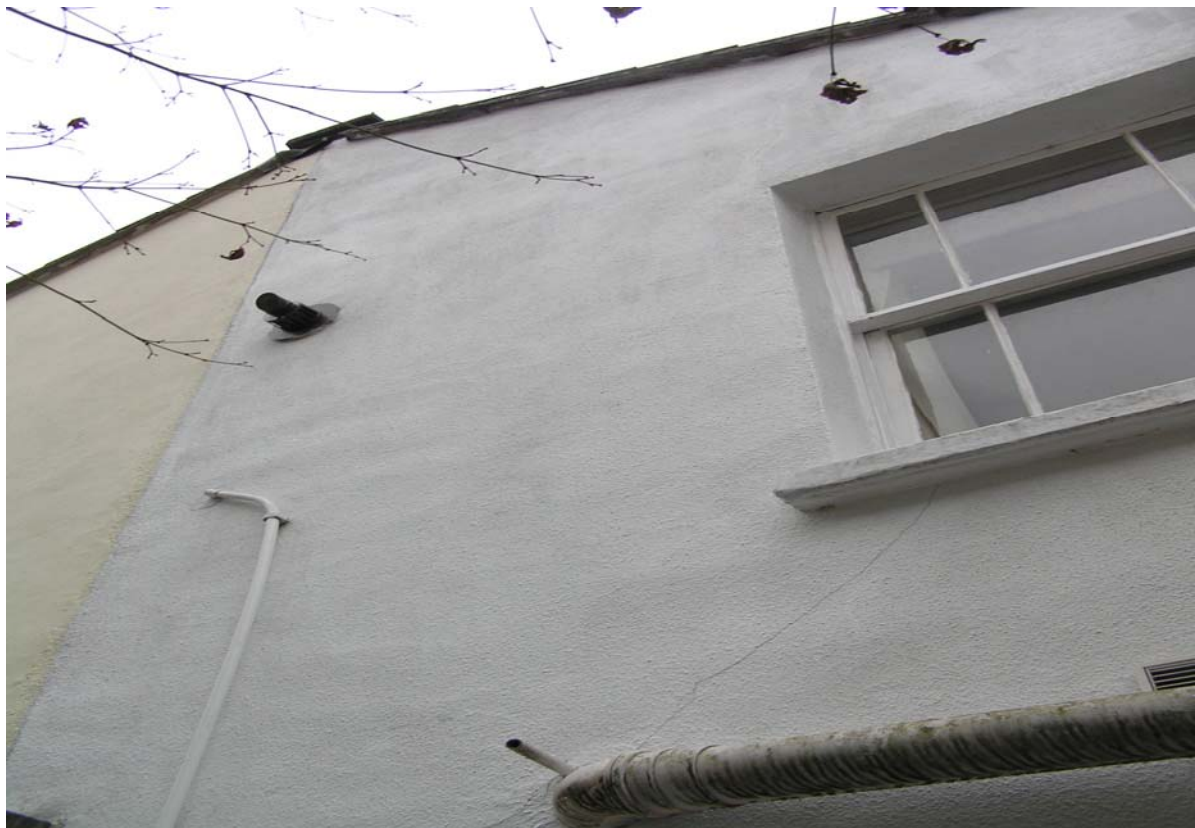
The walls in general appeared satisfactory and I saw no evidence of significant cracking or distortion to give me cause for concern. There are signs of some minor distortion or movement within the walls to the rear of the property which would indicate that the house has suffered from some structural movement in the past, although these cracks are relatively minor in nature and generally occur in natural weak spots in the structure, such as above

window heads etc. The cause of this cracking is unclear although it may be as a result of minor settlement or vibration through general household movement, such as walking on floors, slamming doors etc.

The cracking is only visible to the rear of the house and is relatively minor. I do not believe that it is indicative in any way of any significant subsidence of the property as a result of a significant defect to the foundations or a change in ground conditions, but more as a result of general minor movement as would take place in all structures. Nevertheless, the position should be monitored and remedial work may be required if the position worsens. Clearly, without carrying out a prolonged period of monitoring I am unable to determine whether the movement is historic or ongoing. However the current position does not give me cause for significant concern. I would however recommend that the cracks are repaired in order to prevent further deterioration of the render as well as the possibility of water ingress.

The render to the rear elevation is generally sound but in slightly worse condition to that on the front. There is a sign of hairline cracking beneath the rear bedroom window extending toward the soil pipe opening in the wall. There are also signs of movement and vertical cracking above the head of this window to either side. This cracking would be indicative of some form of structural movement although there is no evidence of corresponding cracking internally, although this is only true of a couple of the cracks and not all. Those internal cracks which are present are hairline only and occur in common weak spots in the building such as beneath windows etc which would indicate that the movement is minor in nature. I have no way of knowing if the movement is ongoing or has ceased. Therefore I would recommend that the position is monitored and if the cracking gets worse than remedial action is carried out. At present the cracking is minor and although indicative of movement it generally does not give me cause for too much concern.

Cracking to rear elevation

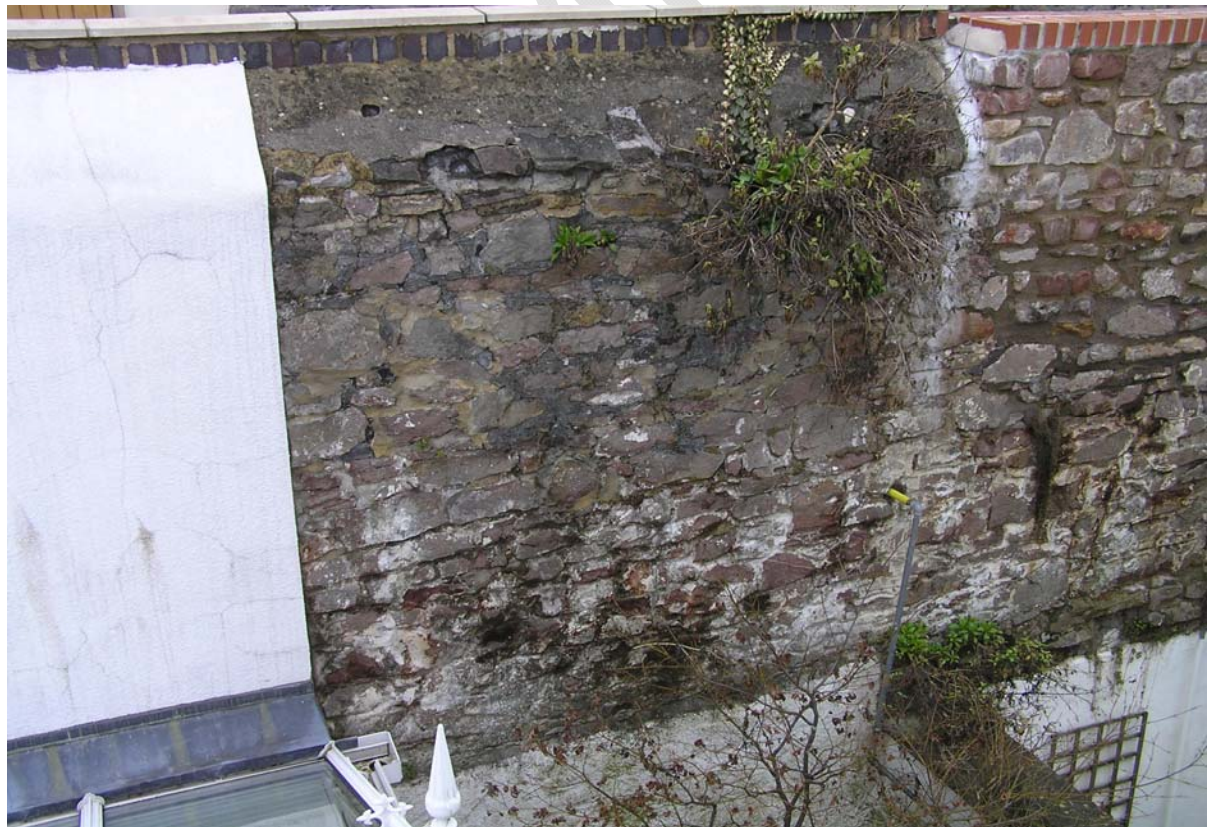
The render to the rear boundary wall is generally satisfactory at low level within the courtyard however the render at high level is badly cracked and crazed and will deteriorate over time. A remaining section of the rear wall is of fair faced stone. It should be monitored in detail because if any render falls from the wall it has the potential of coming through the glazed kitchen roof. I would recommend that the position is assessed at close quarters and any remedial work carried out immediately. This render is applied as a decorative finish to the stone wall which separates the house from the high level road to the rear. I was able to inspect this wall from the road side and it would appear that the wall is not a continuous wall running the full length of the terrace, but a series of interconnected walls of differing types of construction. This makes me believe that the walls are the responsibility of the individual property owners as opposed to the local authority although this will need to be confirmed with your solicitor.

The wall appears sound although large areas of mortar pointing are missing and I would recommend that the wall is repointed to ensure that it does not lose any of its stability. The wall does not show signs of any significant distortion or movement therefore I do not believe that the cracking to the render is as a result of any structural movement. The cracking is likely to be due to shrinkage and an inappropriate render mix having been used.

Wall and cracked render to rear garden wall

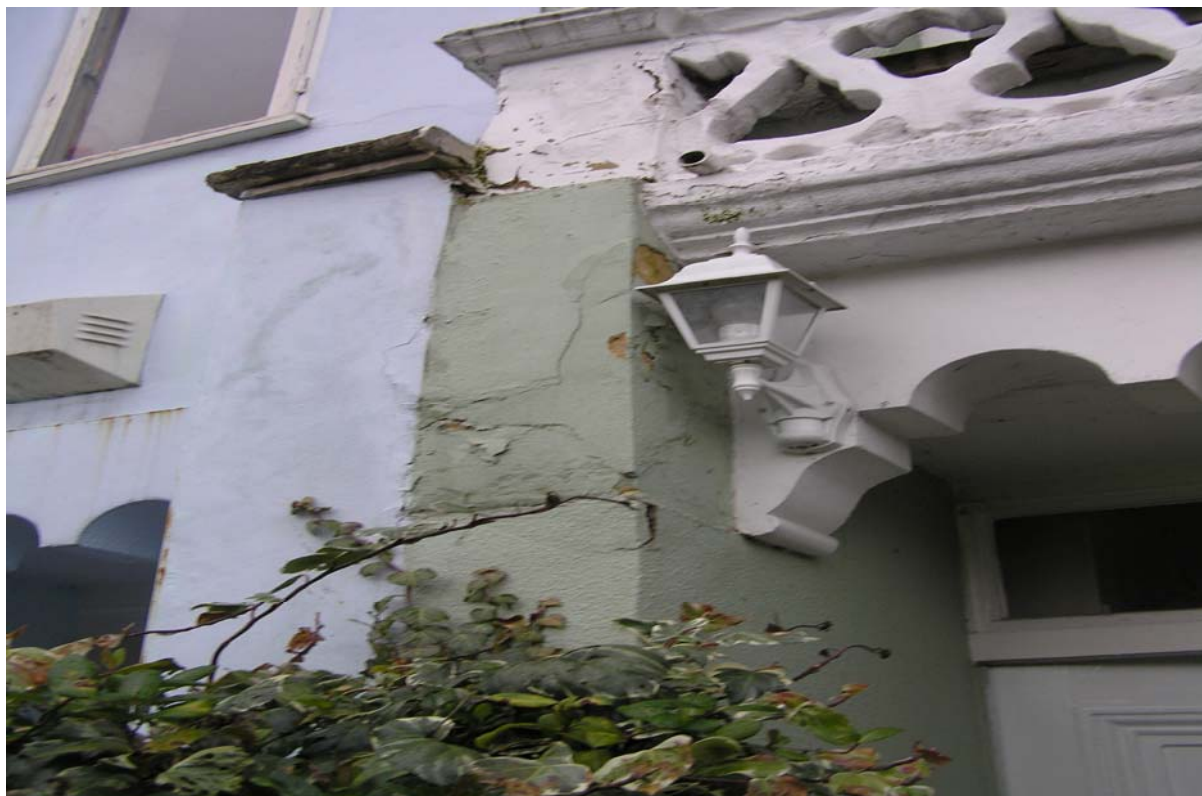
There are areas of render to the front elevation where it is hollow and breaking down and repair will be required. This generally appears where the original decorative stonework has been rendered and painted, although it is not necessarily limited to those areas. It is not always a desirable option to render over stone which should be allowed to breathe. The render if not correctly applied, creates a waterproof background which does not allow moisture to evaporate from the stone and thus either the moisture appears as dampness internally or causes the render to blow externally which it has done in this instance and has caused the finish to fail in isolated areas.

Damaged render and paintwork to front elevation

I would recommend that if the blown areas are to be repaired in the future that you either expose the stonework or use the render with an appropriate mix to allow some evaporation of the moisture contained within the stonework.

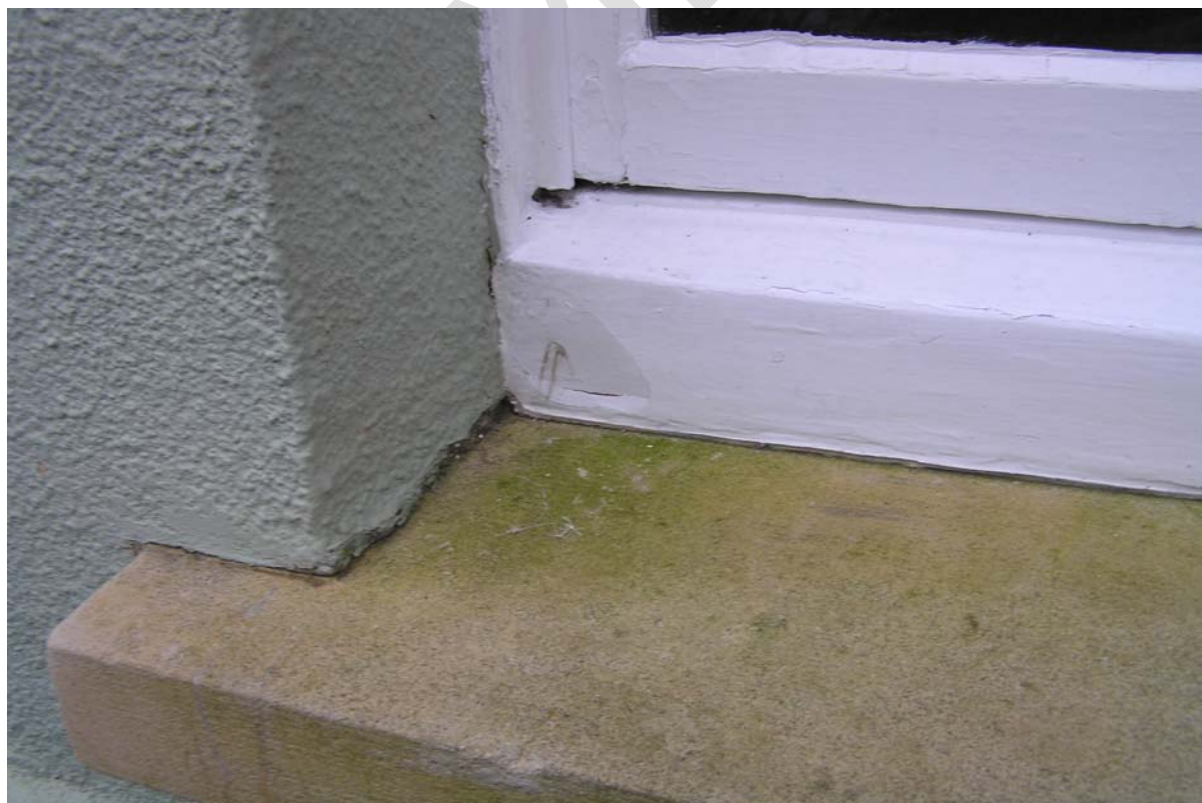
The sill to the ground floor sitting room window has rotten and replacement of the sill will be required although the remainder of the sashes themselves and the box in which they sit generally appear to be in sound order. I can confirm that I saw no evidence of rot to the remaining windows.

Wet rot to front sash window

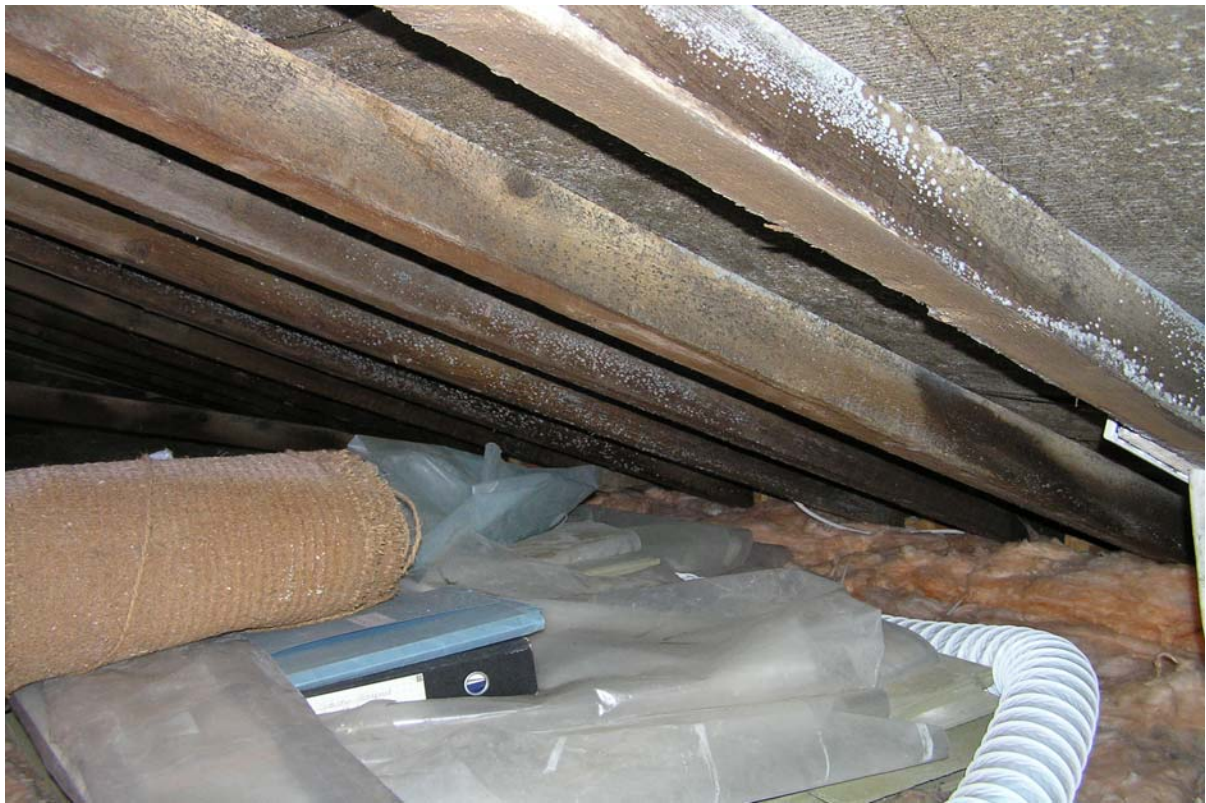
The roof void when entered does have a very damp and musty smell to it and the environment is generally very damp. This environment, together with a lack of ventilation is perfect for wet and dry rot to propagate.

It can clearly be seen on the timbers that water ingress through the roof has taken place albeit it is impossible to tell whether this water ingress is historic or ongoing. At the time of my inspection the weather was dry and therefore I saw no evidence of current leaking and generally other than the chimneys and front parapet wall the majority of the roof areas appeared sound. Therefore I suspect that any staining is historic although I cannot categorically confirm this without inspecting the house during a time of heavy rainfall. What I can however confirm is that a large proportion of the roof timbers, particularly within the right hand roof void show signs of wet rot and white staining indicative of the fungi *Poria Vaillantii* and immediate treatment will be necessary. Provided that the source of the moisture ingress has been stopped and additional ventilation installed, this type of wet rot should cause no problems to the integrity of the timber, however should a reoccurrence of moisture occur the possibility of an outbreak of dry rot may be likely.

This type of wet rot is prevalent in warm stagnant conditions and thus the roof void is the perfect environment for it to propagate. The fungi should be at a stage where it can be treated using a fungicidal emulsion and as long as any water ingress has been stopped the timbers will dry out and should not lose any of their strength, however it is essential that in conjunction with treating the timbers a series of additional vents are installed within each roof slope to provide a greater degree of ventilation to prevent the onset of further rot. It is also essential that any damp ingress is rectified and thus the areas of the roof that require repair and are detailed above should be addressed.

Wet rot and staining to roof rafters

Although ventilation has been provided to the roof by way of 2 no vent tiles externally to the right hand roof slope and 1 no to the left hand to the right hand side 1 no of these is used to the extract of the ensuite bathroom therefore leaving only one tile to serve the roof on each side. The amount of ventilation is wholly inadequate and I would recommend that additional ventilation is installed immediately.
