BUILDING SURVEY
OF

8 SHELLEY CLOSE
ITCHEN ABBAS
HAMPSHIRE

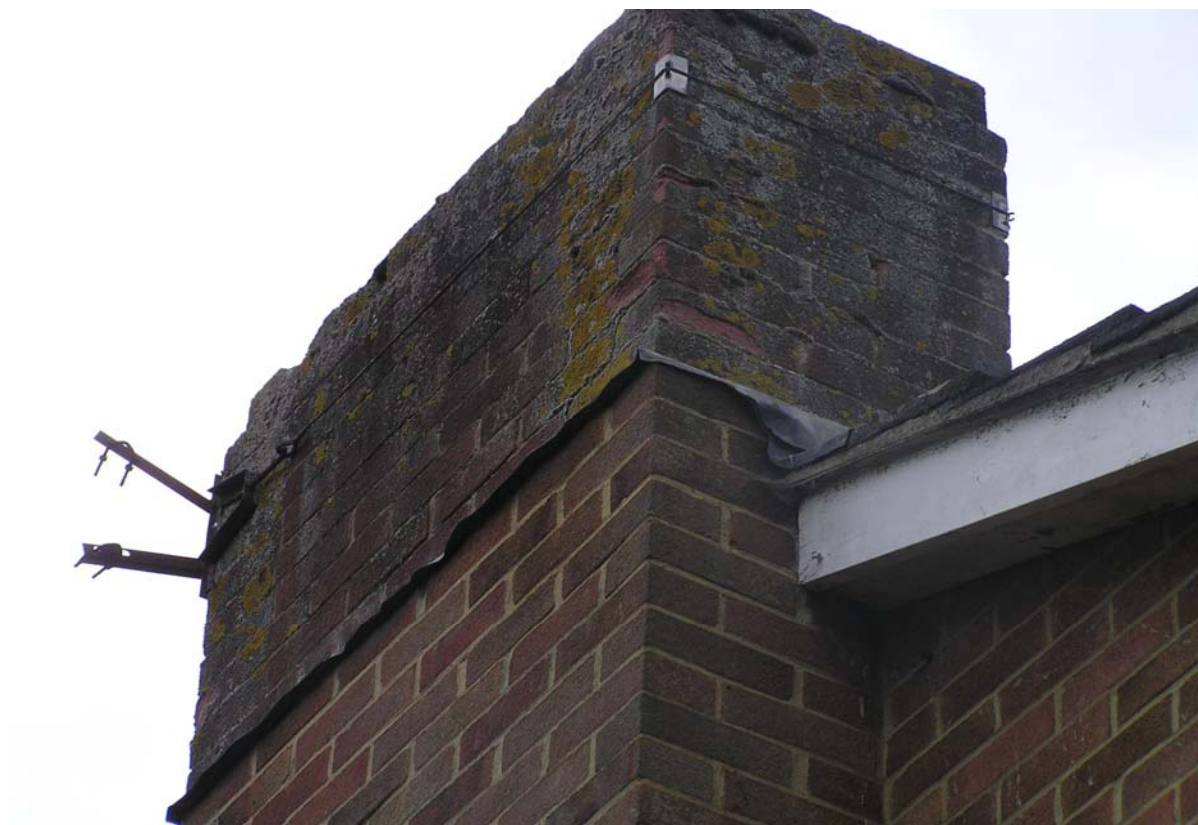
Chimney

The main bulk of the exposed chimneystack to the flank wall is generally in good order. The chimneystack is constructed of brickwork to its entirety and the bricks generally appear to be in good sound order and free from significant cracking or defect. The mortar pointing to the bricks also appears to be in good order and free from any significant defect.

The remaining brickwork to the stack generally appears to be in sound order and free from significant cracking or deterioration. The stack itself does suffer significantly from moss and algae growth and I would recommend that the brickwork is cleaned down at the same time as the roof is cleaned in order to expose the fairfaced surface of the bricks beneath. The mortar pointing to the bricks generally appears to be in reasonable order and free from significant cracking or defect. I suspect that some minor hairline cracking is present which may require some re-pointing but this is highly common and on the whole the condition is reasonable.

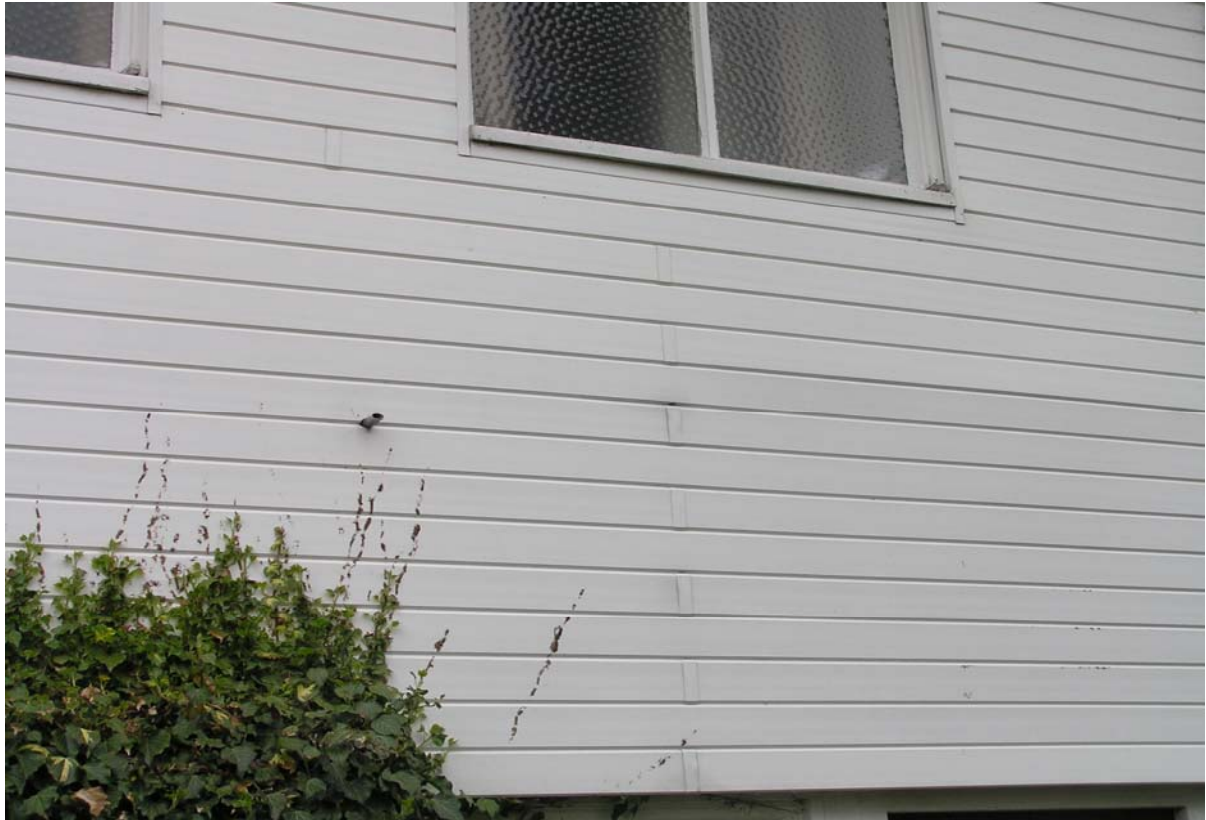
Joints within PVC Cladding

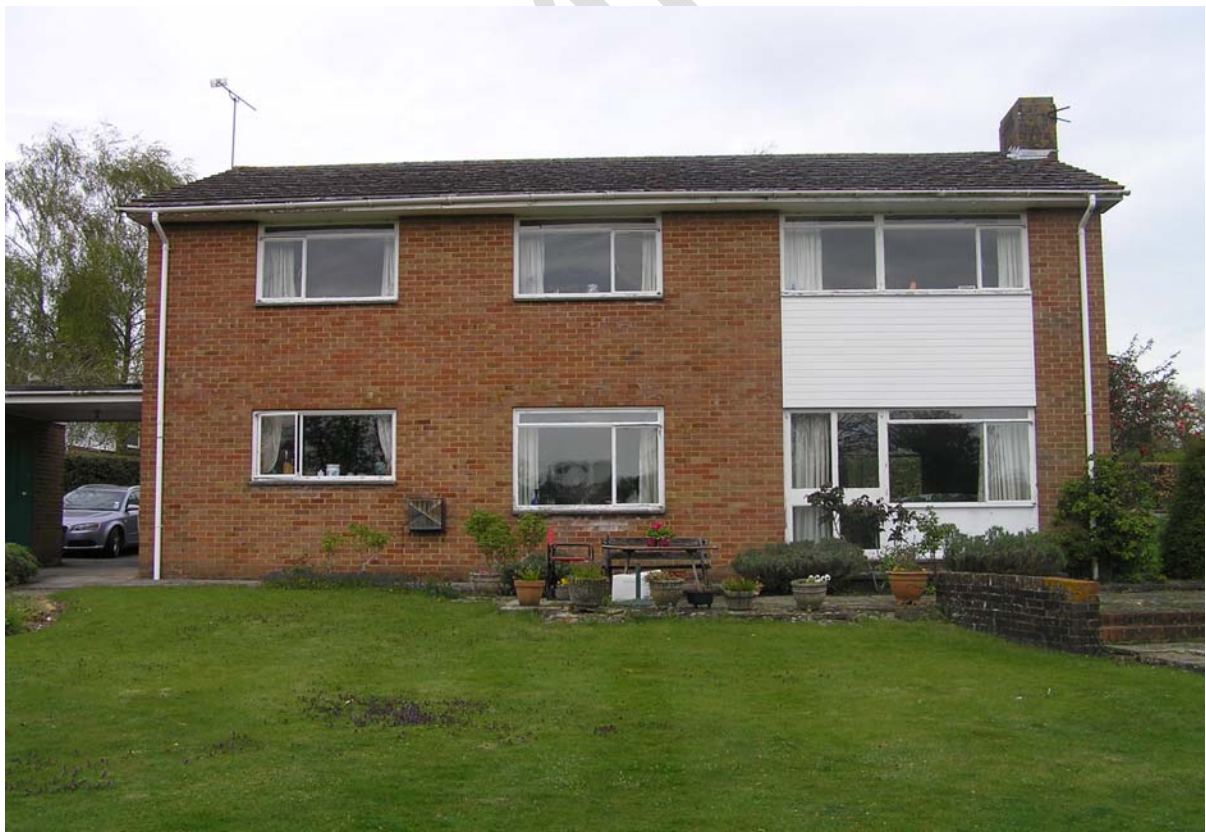
Rear Elevation

The pointing to the rear of the house is in worse condition than that to the front, probably as a result of it being exposed to the prevailing weather. This pointing particularly adjacent to windows does show signs of some erosion and deterioration and gaps within the pointing are now visible. The exact cause of these holes and gaps is unclear however there is a possibility that they could be created by mortar bees which eat into the mortar and create

There are signs of efflorescence to the brickwork upon the rear elevation. Normally such efflorescence only manifests itself in new brickwork where the salts leech from the bricks at times of dampness and rainfall. In this particular property it is unclear as to why such efflorescence is now present after this length of time however it is an indication that the bricks have become wet and caused the salting to take place. This salting is not necessarily an indication of any significant defect and it should be possible to clean the bricks in the affected locations to remove the salting although even after cleaning you may find that it reoccurs and further periodic cleaning may be necessary. I can confirm that I tested the walls internally for dampness behind the badly affected areas and registered no unduly high levels of dampness in these locations which would indicate that the salting relates to an external defect only and does not manifest itself internally. Indeed much of the salting does appear beneath windowsills and may be as a result of water runoff from the concrete sills as well as possibly some water ingress as a result of the poorly weatherproofed windows as detailed below. Of course, the walls are of cavity construction therefore I cannot completely rule out the possibility that some moisture is penetrating the external wall but I can confirm that if it is, it is not currently causing any problems and the cavity is performing one of its tasks as intended..

such holes. In this regard I would recommend that the area is inspected by a specialist to confirm whether this indeed is the case and what remedial action may be necessary. If, further to these inspections it is determined that the pointing is damaged merely through erosion, then I would recommend that the affected areas are re-pointed in order to make good the mortar. If mortar bees are present then some treatment may be necessary prior to re-pointing.

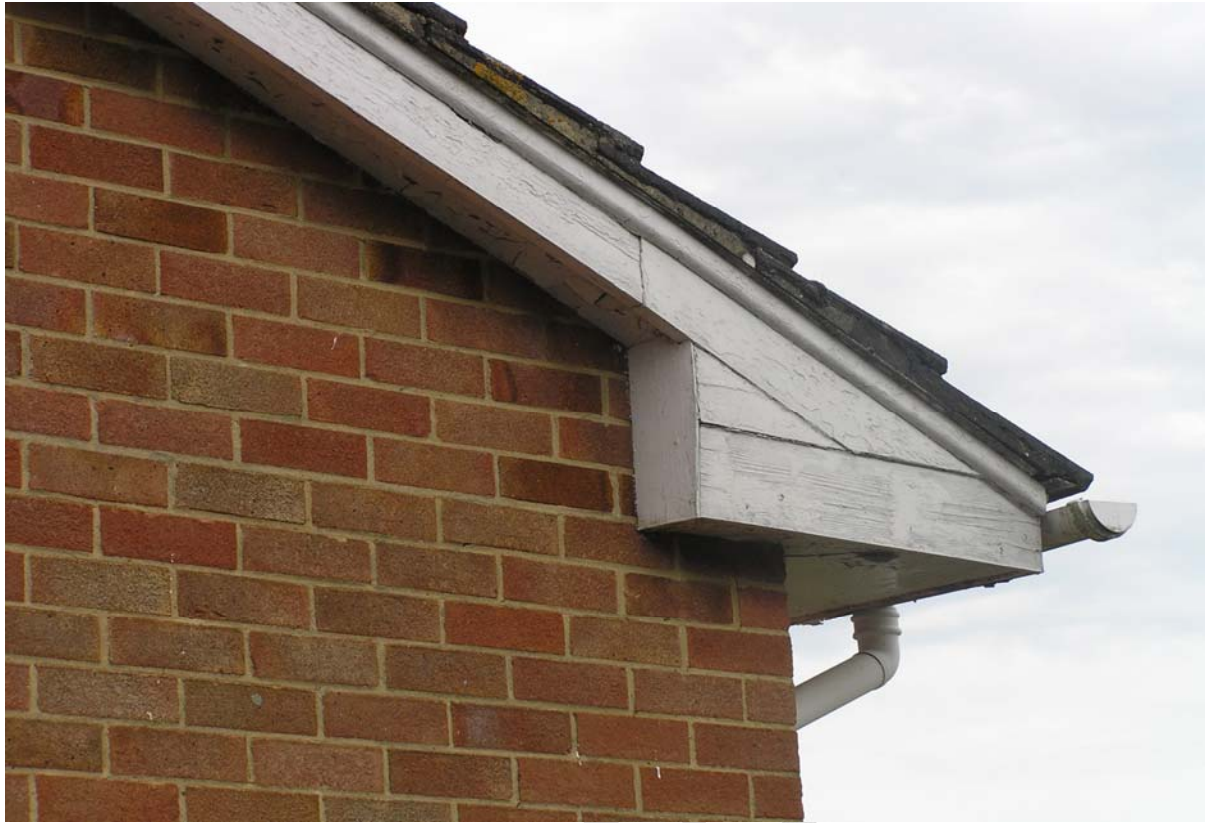
The timber fascia generally appears to be in poor order. The decoration has broken down and the exposed timber beneath has started to rot in areas. Although some areas may be able to be salvaged I suspect that the entire rear fascia will require replacement as too will the front fascia although the gable ends are in slightly better order and repair may be an option in these locations as opposed to replacement. However on the whole the fascias are in poor order and full replacement should be budgeted for.

The underlying soffit board to the perimeter of the house is generally in reasonably sound order although the decoration once again is poor and the boarding does show signs of significant staining and dirt collection. Due to the presence of dirt it is unclear as to whether the soffit boarding has suffered from damp and staining however I suspect that some

Flaking Paint to Soffit and Fascia

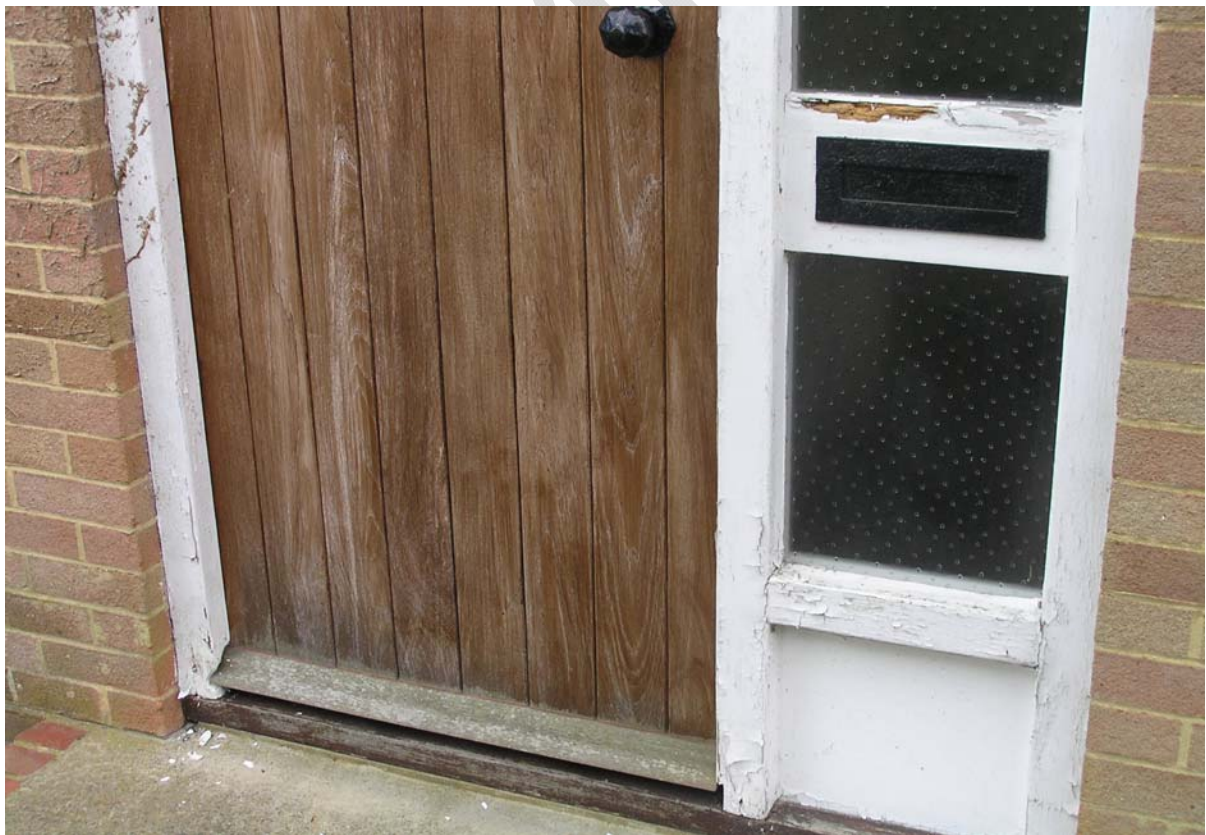
door does not appear to be rotten in any way and therefore reapplication of the varnish should suffice to keep the door in good functional order. The door furniture is original to the house and consists of a knocker, pull handle and a Yale lock. This furniture has been decorated and redecoration will be warranted however the furniture is functional and in keeping with the house. The timber surround to the door is generally in fair order although at low level and also adjacent to the letterbox it does show signs of rot and deterioration to the timber beneath the decorative surface. Once again the decoration is also poor and full redecoration will be warranted. I suspect that the timber frame can be salvaged and repair and some splicing in of timber will be necessary but I would not anticipate the need to completely replace the door and surround unless you wish to do so. I reiterate that full redecoration will however be required as a minimum together with some timber repair.

Rot to Front Door Frame

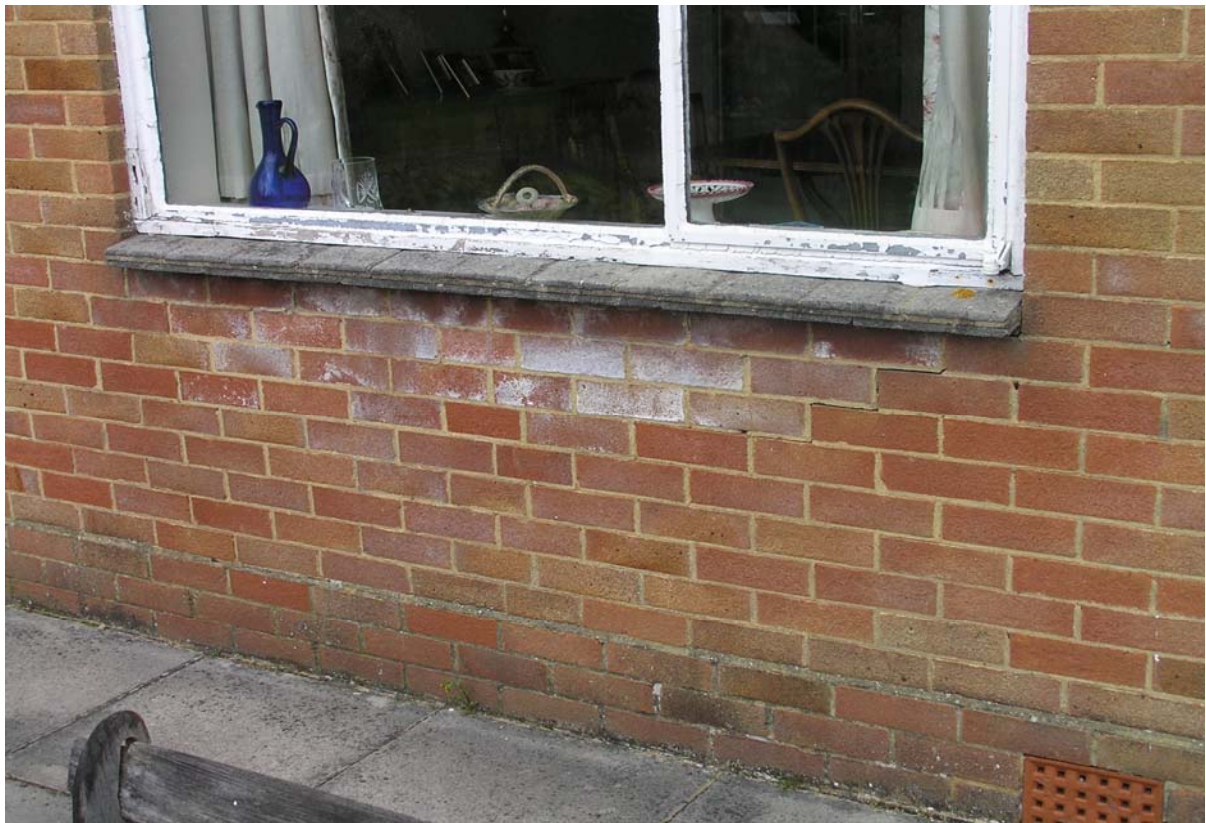
On the whole the windows are still functional and although the decoration is extremely poor it would appear that the majority do not show signs of significant corrosion as a result of the bare metal beneath showing through. It will however only be a matter of time before corrosion does set in and therefore if you propose to retain the existing windows then immediate redecoration is required in order to prevent the onset of corrosion to the metal frames.

The timber frames in which the windows are set also generally appear to be sound and free from significant rot or deterioration despite the poor quality of paintwork. There are signs to individual windows, particularly on the rear elevation that some rot has occurred and indeed, in particular to the dining room window it is apparent that previous repairs have subsequently broken down and further rot is present. The windows to the rear elevation where they face the prevailing weather are in significantly worse order than those elsewhere and if the windows are to be retained then some replacement of the timber surrounds will be necessary as well as patch repairs and of course complete redecoration. It has to be said however despite the poor visual appearance of the windows they are not all beyond repair and if desired they could be salvaged, albeit in a modern house these windows are now significantly outdated and the benefits in repairing and redecorating them must be considered limited as opposed to opting for complete replacement as has been done to the majority of surrounding houses.

General Condition of Windows

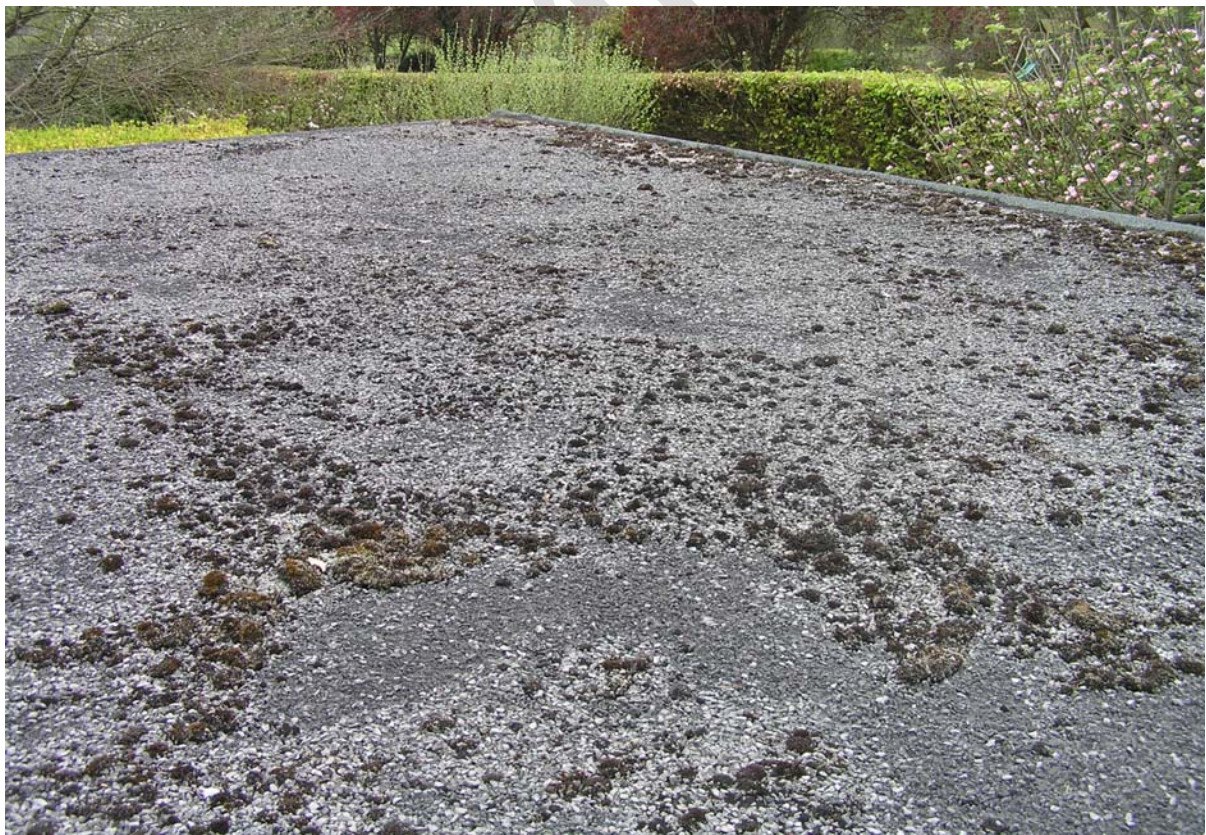
Flat Roof to Garage

The felt to the roof is generally dated, old and cracked although there are no signs, either within the garage, or the car port that the roof is leaking in any way. I would anticipate that the felt is original to the building and has never been replaced and as such it has performed beyond its anticipated lifespan and replacement is likely to be required in the near future. There are signs of splitting and cracking to the felt which has become brittle in areas and although the roof could be nursed through with patch repairs in the short term, I would envisage that full replacement of the felt will be necessary in the relatively near future.

The edges to the roof in particular are exposed to a greater degree and it is in these areas where the greatest amount of defect shows, although even in these locations I can confirm that the felt does not show any signs of any significant ripping or tearing and despite being dated and showing surface crazed cracking it appears sound at present. I reiterate however that it is nearing the end of its natural life.

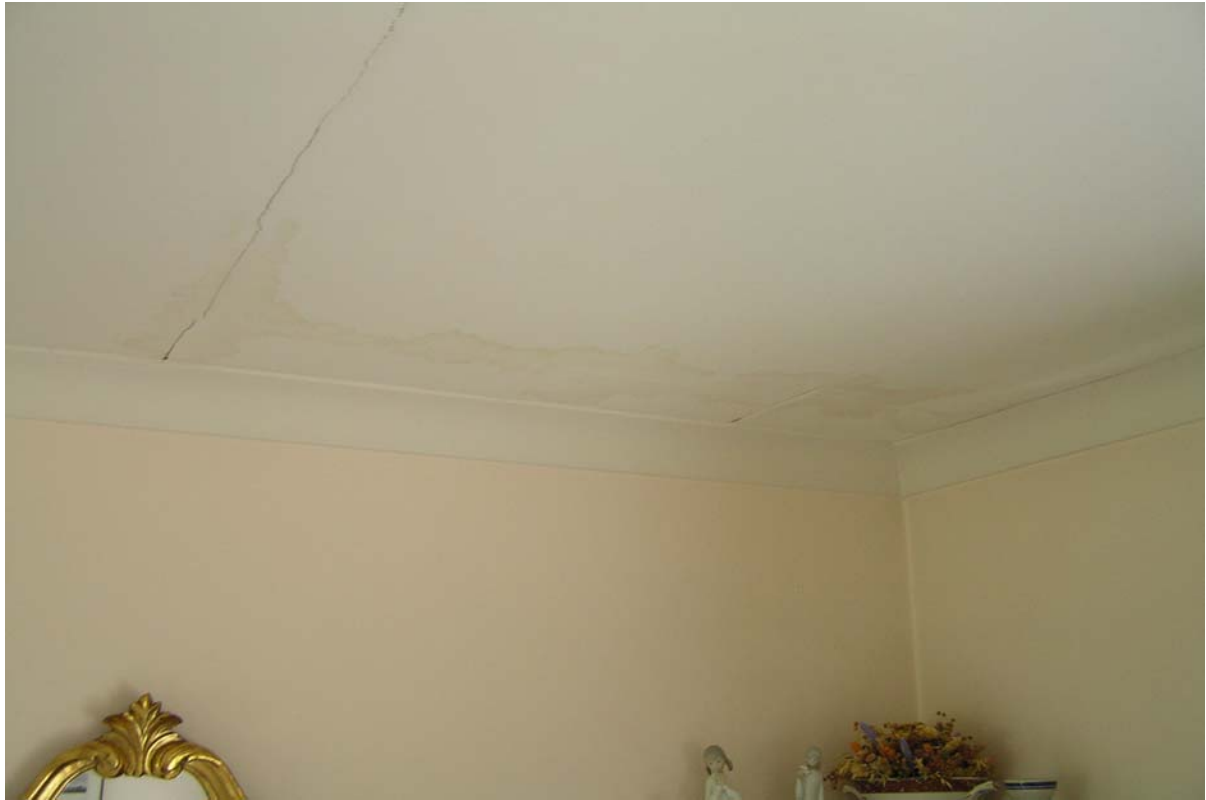
Damp Staining to Ceiling in Sitting Room
